**Impacts of Weathering Processes on Kousa  
Pasha Fort, Alexandria, Egypt – A Study in  
Applied Geomorphology**

### **Abstract:**

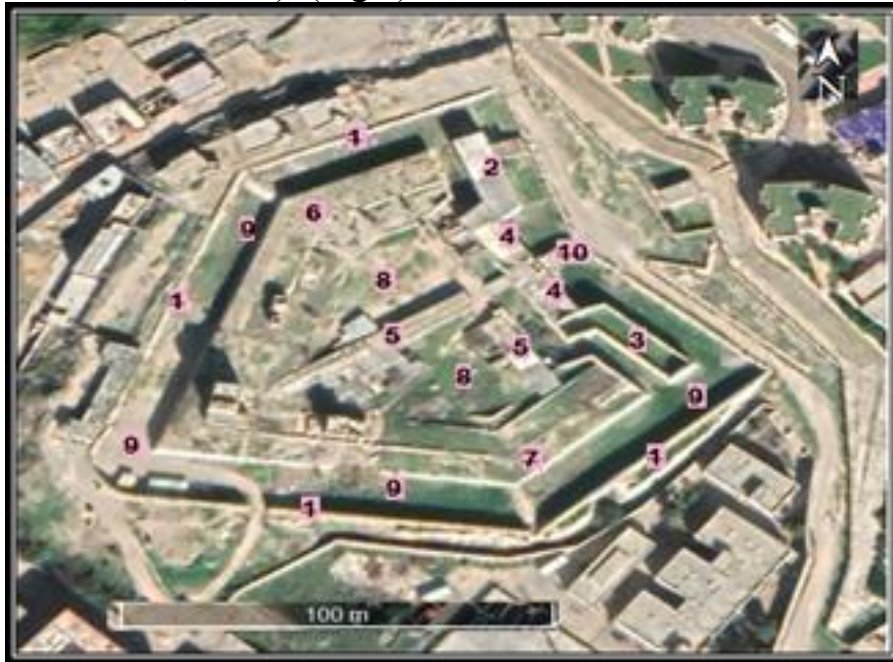
The fort is a rectangular construction that is not on one level as the north and southern towers stand out. The fort consists of two floors. The ground floor is of the same level as the trench surrounding the fort. It is 8 cm deep.

**Figure .3** : Scheme of the Kousa Pasha Fort , Meaning of numbers that : (1) Fortress walls (2) Northern Tower (3) Southern Tower (4) Storehouses (5) Internal fort (6) Northern tunnels (7) Southern tunnels (8) Yard (9) Trench (10) Entrance of the fort .

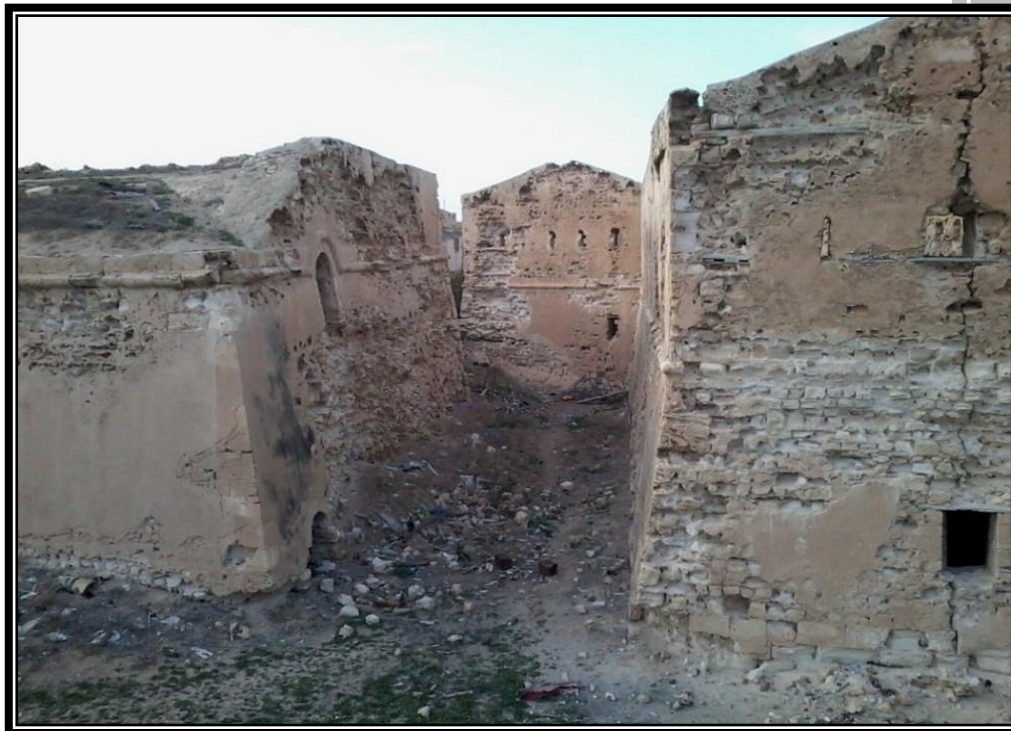
The fort was damaged as a result of being affected by multiple weathering processes. Besides, the weathering rate varies according to the surrounding environmental conditions and the type of building material. This is because the weathering process is the result of the interaction between the internal structure of the stones, their mineral components and the prevailing environmental conditions. (Delalieux F, et al, 2001). [3]. (Ruiz-Agudo, et al, 2007). (Fig.4).

**Figure 4:** Remains of Kousa Pasha fort.

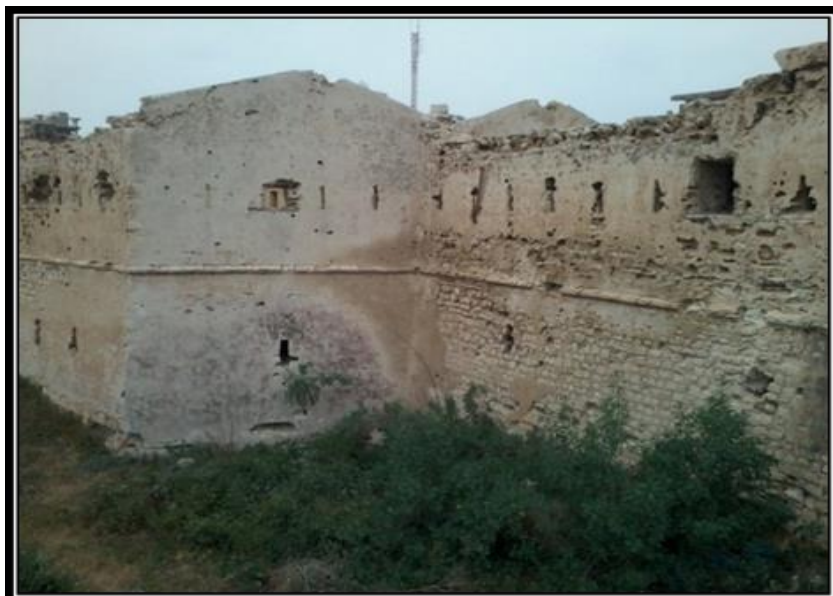
Moisture also significantly contributes to the weathering of forts. Water drops gather on the external surfaces of forts because of the properties of the construction materials, including porosity that allows water to pass to the inside so that soluble salts can dissolve in water. With the rise of temperature in daytime, such water rises in the construction materials bearing with it salts that crystallize, in turn, on the external surfaces of the construction stones where flowers grow. As the process recurs, intensive pressures on the peripheral layers of the construction stones happen, leading in the end to their fragmentation and collapse. (Winkler, 1973) (Fig 5).

**Figure 5:** The effects of Moisture on the northern profile of the northern tower of Kousa Pasha Fort.

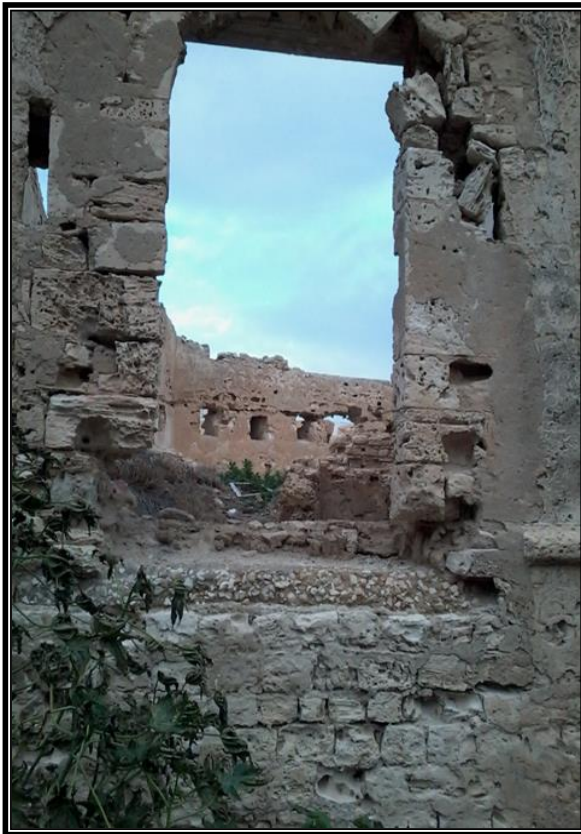
Kousa Pasha Fort was built of Oolitic limestones. twelve weathered samples were collected from different positions of the fort for examination. (Fig6).

**Figure 6:** The entrance of the northern tower, consisting of oolitic limestone.

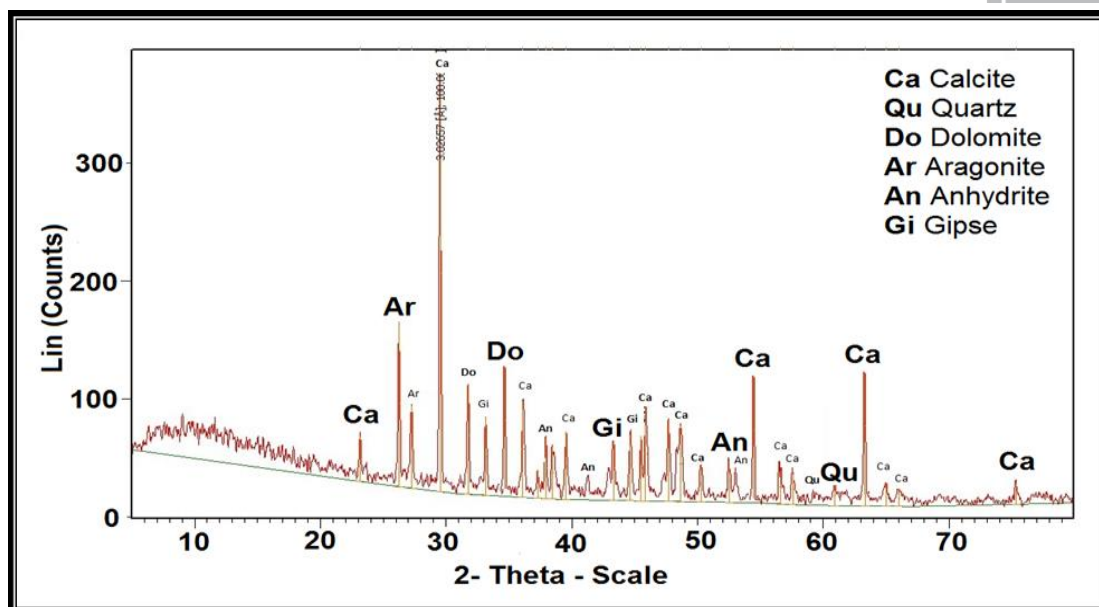
Sample is essentially formed of calcite along with secondary minerals such as dolomite, Aragonite and quartz. The stones are of the dolomite limestone type as a result of the existence of dolomite in the samples. (Fig.12).

**Figure 12:** X-ray diffraction chart of The Mineral Structure of Limestone sample collected from construction stone of kousa pasha fort.

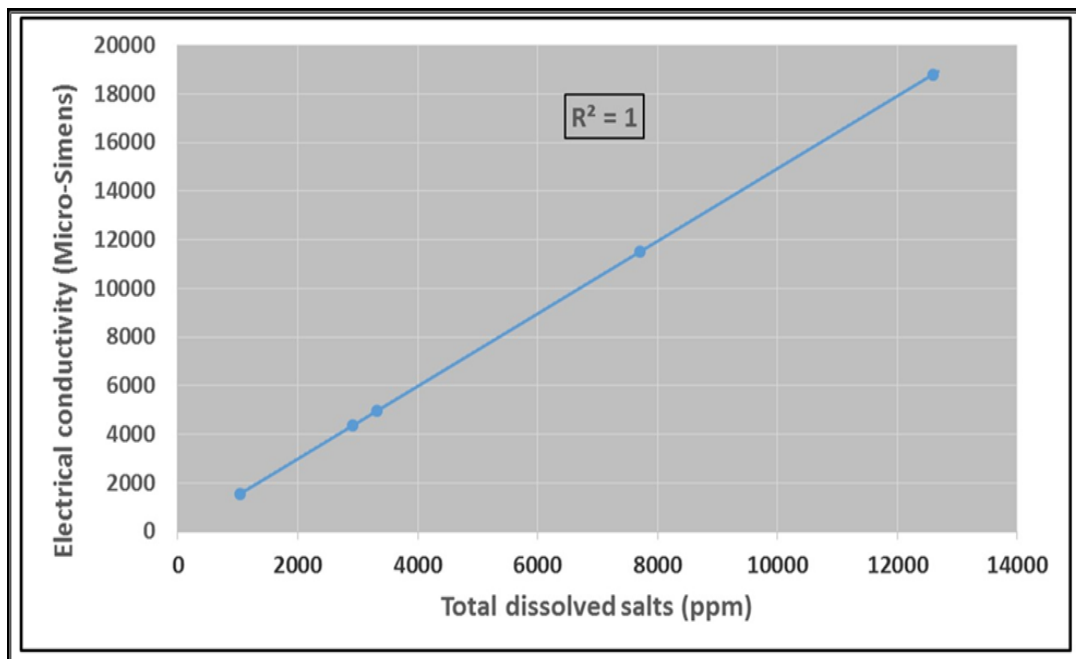
Incidentally, the electrical conduction of water is related to the salts dissolved therein. The more concentrated salts are in water, the more conductible of electricity water is. From the observation of the relation between the values of electrical conduction and the total dissolved salts in all of the tested samples with their types — whether limestones or concrete added to the construction paint. It is found that it is a strong direct correlation. Besides, values of electrical conduction went up with the rise of the total dissolved salts, (Fig, 13).

**Figure.13:** the Relation between electrical conduction and the dissolved salts in the samples of the construction materials.

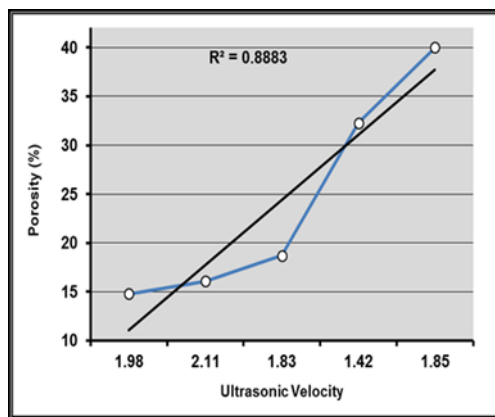
The results are listed in [Table.2]: The results indicate, that Weathering rates directly influence the velocity of ultrasonic waves and the values of the internal friction of the waves in the construction materials. The velocity of ultrasonic waves in the samples ranges from 1.42 to 2.11 km / sec. None the less, the values of internal friction range from 6.37 to 9.4 because of the damage of the internal texture of the construction materials since it is badly affected by weathering processes. (Maria, et al, 2000). (Fig.14).

**Figure 14 :** Relationships between Ultrasonic wave velocity and (a) stone porosity , (b) coefficient of stone water absorption examined for weathered building materials samples from kousa pasha fort.

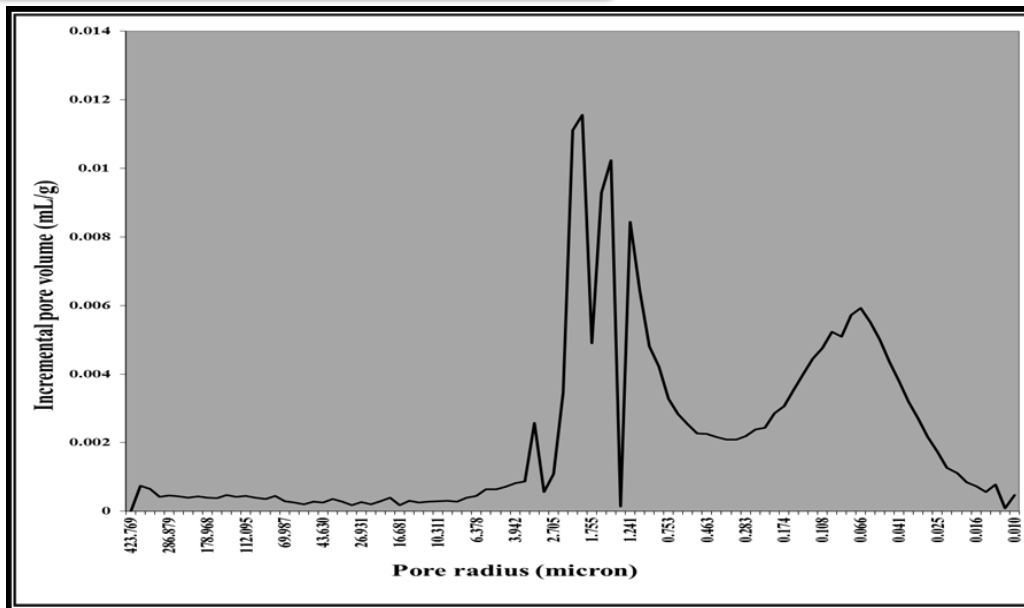
**Figure 16:** Graphical relationship between Pore radius and Incremental pore volume (mL/g) for Oolitic limestone on construction materials sample from kousa pasha fort.

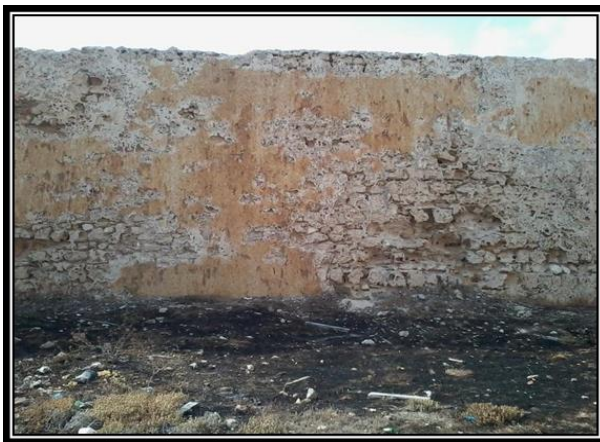
The mortar falls as a result of phasal transformations of the mineral granules which form mortar because of its thermal behavior of storing and losing thermal energy. This causes the separation of the layers of mortar from the walls in the form of crusts due to the crystallization of salts in the external layers of the surfaces of the construction materials, especially the mortar. When solvents of salts dry by evaporation, salts grow and flourish. With the recurrence of such a process, strong pressures are caused on the layers of the mortar, eventually leading to its fragmentation and fall (Mottershead, 1989). (Fig. 17).

The eastern and southern façades of the buildings of Kousa Pasha Fort have the biggest share of the fall of mortar owing to the exposure to the common factors of weathering, especially the maritime effects—percentages of mortar fall range from 60% to 75 %.

**Figure17:** A model of mortar fall of Kousa Pasha Fort.

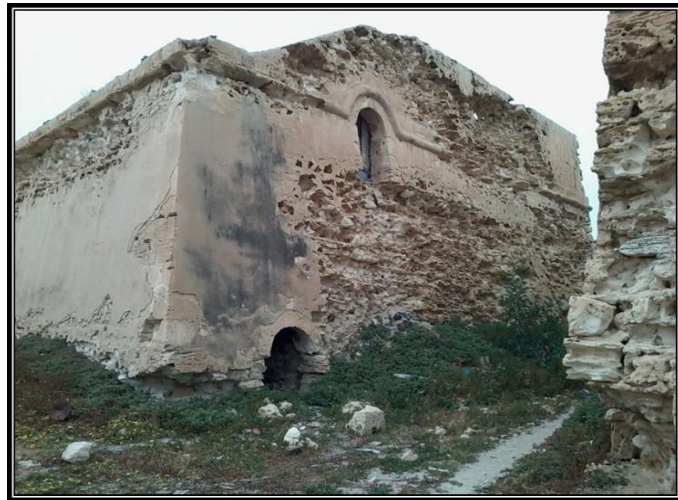
Effects of differential weathering appear in the middle and upper parts of the external façades of Kousa Pasha Fort because of the variation in the resistance of the construction materials to weathering processes.

Besides, the upper parts of the walls receive the highest proportions of the common weathering effects in the site. The percentages of differential weathering vary from 55% to 85%, and the amount of differentiation varies from 30 to 50 cm.

**Figure 18:** The effect of weathering processes in the Eastern façade of the southern tunnel of Kousa Pasha Fort.

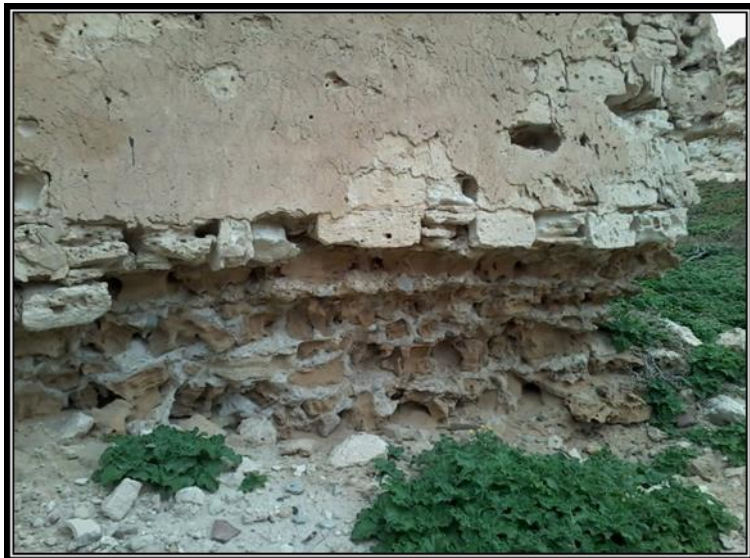
The lower parts of the buildings are exposed to lower erosion because of being influenced by the subsurface water that leaks to the construction materials and causes the salts therein, or in the soil surrounding the foundations of the buildings, to dissolve. Therefore, the salt solvents move to the exposed surfaces where they start to crystallize when the water evaporates, leading to the disintegration of such surfaces by means of the topical pressures accompanying crystallization. (Abdel Wahab, 2006).

Lower erosion appears in the lower parts of the buildings of Kousa Pasha Fort with percentages ranging from 10% to 15% of the total façade. The erosion ranges from 30cm to 80cm. (Fig.19).

**Figure 19:** A model of lower erosion in the northern tower of Kousa Pasha Fort.

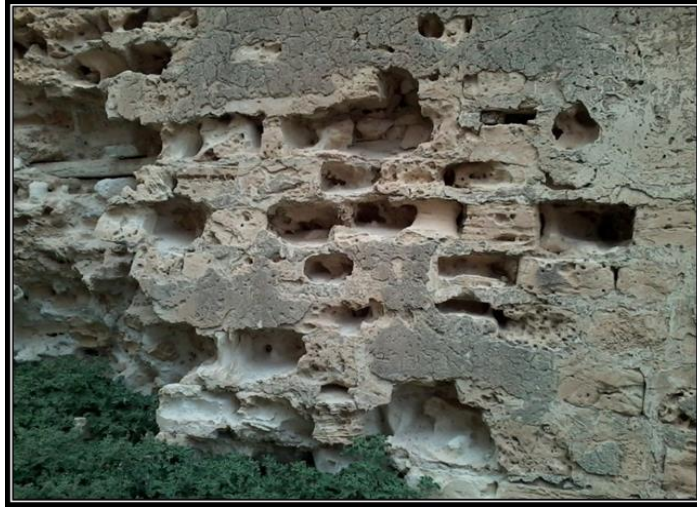
Weathering cavitations appear in the external façades of Kousa Pasha Fort as a result of the construction materials are influenced by saline weathering that activates salt crystallization on the surfaces or below the walls. This causes the back to back fragmentation and disintegration of the construction materials by means of the topical pressures accompanying crystallization. (Mottershead, et al , 1994).

**Figure 20:** A model of the cavitation weathering on the southern tower of Kousa Pasha Fort.

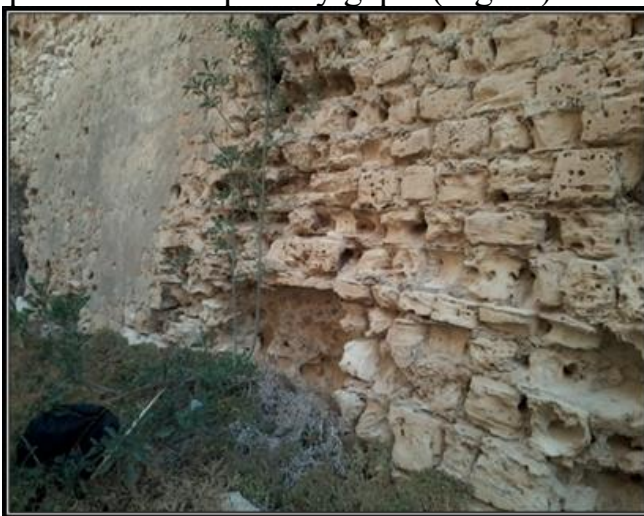
The study of the morphometric parameters of the models of the gaps of dissolution in some façades of the buildings of Kousa Pasha Fort show that the dimensions of the gaps (length, width, depth and circumference) are increasing in one direction. The reason is the similarity of the factors and processes affecting their expansion and deepening. Such factors and processes are, in turn, associated with the consistency of the nature of stones and their installation in the positions occupied by gaps. (Fig.22).

**Figure 22:** A model of the gaps of dissolution in the western façade of the southern tower of Kousa Pasha Fort

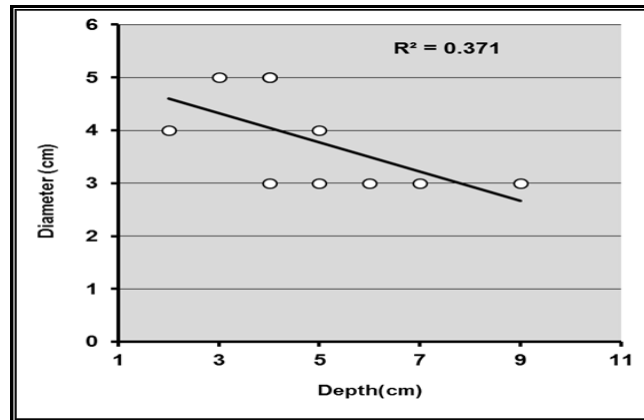
It is noted from (Fig.23) shows some deviation in the values from the straight line in the relation between the depth of the gaps of dissolution in the façades under study and their diameter. This indicates the constant expansion of the gaps by means of their amalgamation in addition to the constant deepening by dissolution and vertical decomposition.

**Figure 23:** the relation between the depth of the gaps of dissolution and their diameter in the western façade of the southern tower in Kousa Pasha Fort.

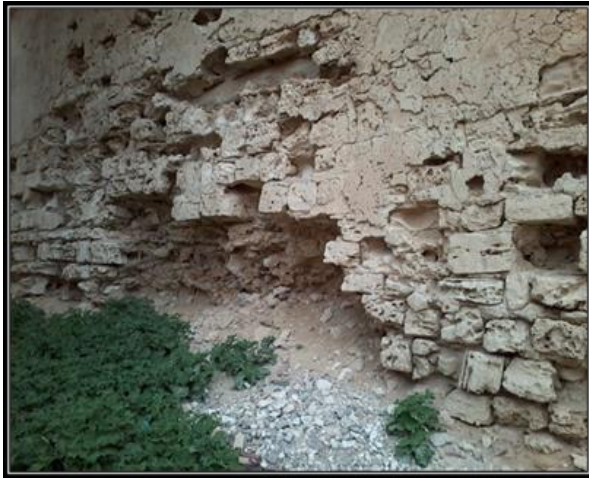
The Granular disintegration appear below the exterior facades of the Kousa Pasha Fort buildings, as a result of the decomposition and disintegration of the construction materials, (Fig.24).

**Figure 24:** A model for Granular disintegration in the eastern facade of the northern tower, Kousa Pasha Fort.

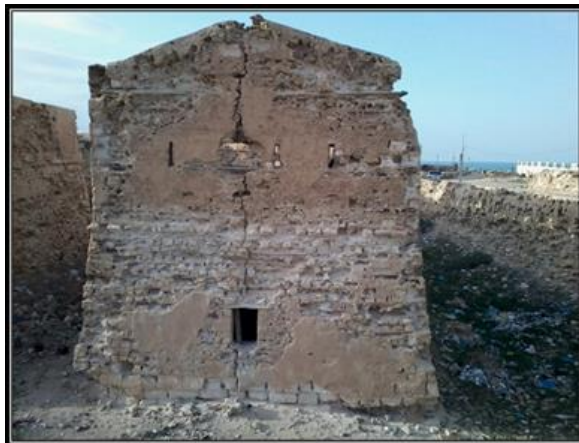
Kousa Pasha Fort is of the buildings with holding walls which are built to resist vertical loads only. The walls of a floor are built. Then, logs are placed on it, and the next floor is built. Thus, no momenta transmission is found between the roof and the walls. When exposed to loads of earthquakes, such walls become vertical organs supported only horizontally at the height of the roofs. When exposed to weariness as a result of the horizontal movement, whatever small it is, vertical and oblique cracks occur in the walls. (Edwards, 2004). (Fig.25).

**Figure 25:** A vertical crack in the southern façade of the southern tower of Kousa Pasha Fort.

Some of the external façades of Kousa Pasha Fort are influenced by vertical cracks owing to the difference in the loads and weariness between the two parts of the same building. Such cracks occur in the buildings with different loads and varying heights such as the eastern and southern façades of the southern tower.
